MEMORANDUM

Date: May 17 2016
To: Mr. Art Leventis
From: Lee Weishar, Ph.D.; PWS
Re: Task 3 Wetlands Delineation Memorandum and Sediment Sampling

Introduction

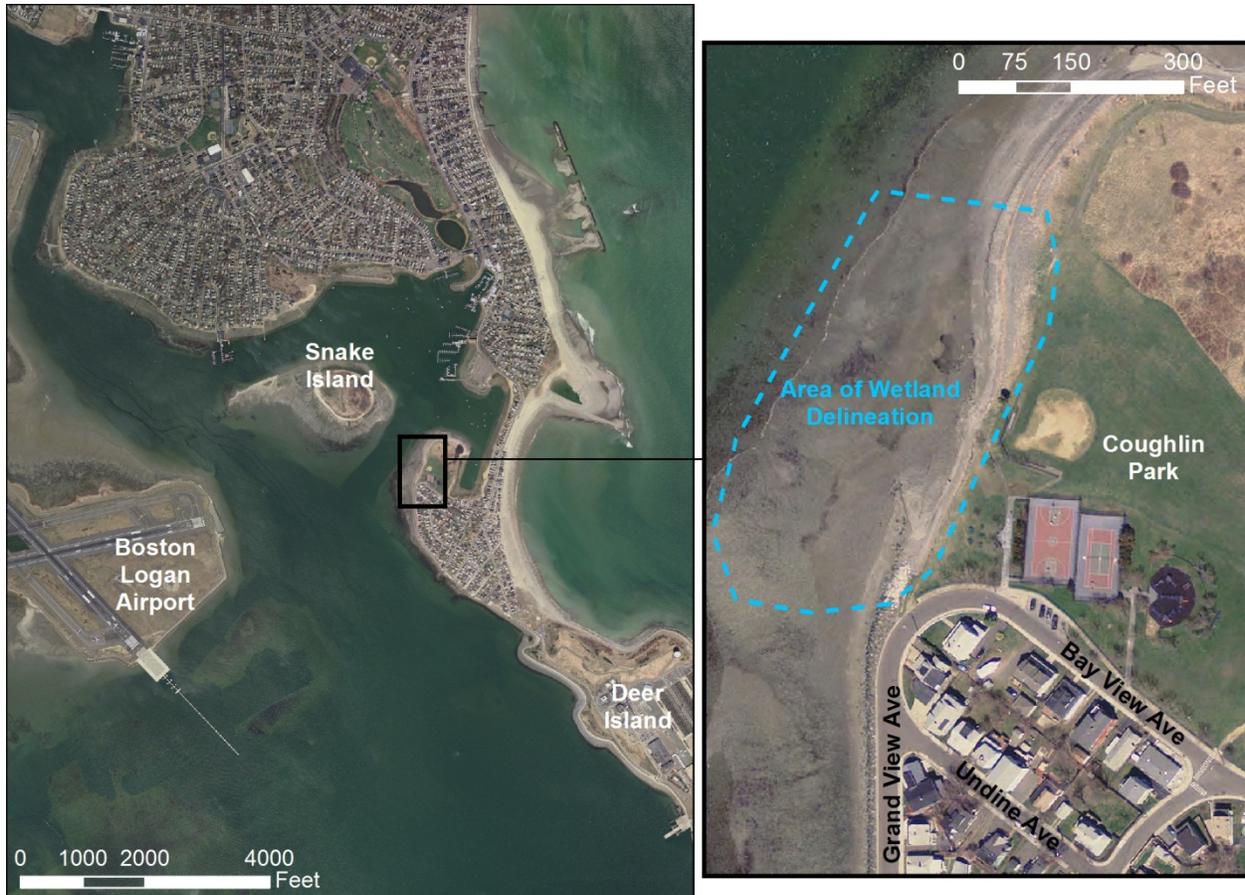
Figure 1. Locator Map. The left-hand figure shows Coughlin Park's location in the regional context, while the right-hand figure shows the area of Coughlin Park that was evaluated during the April 27, 2016 site visit and wetland delineation.

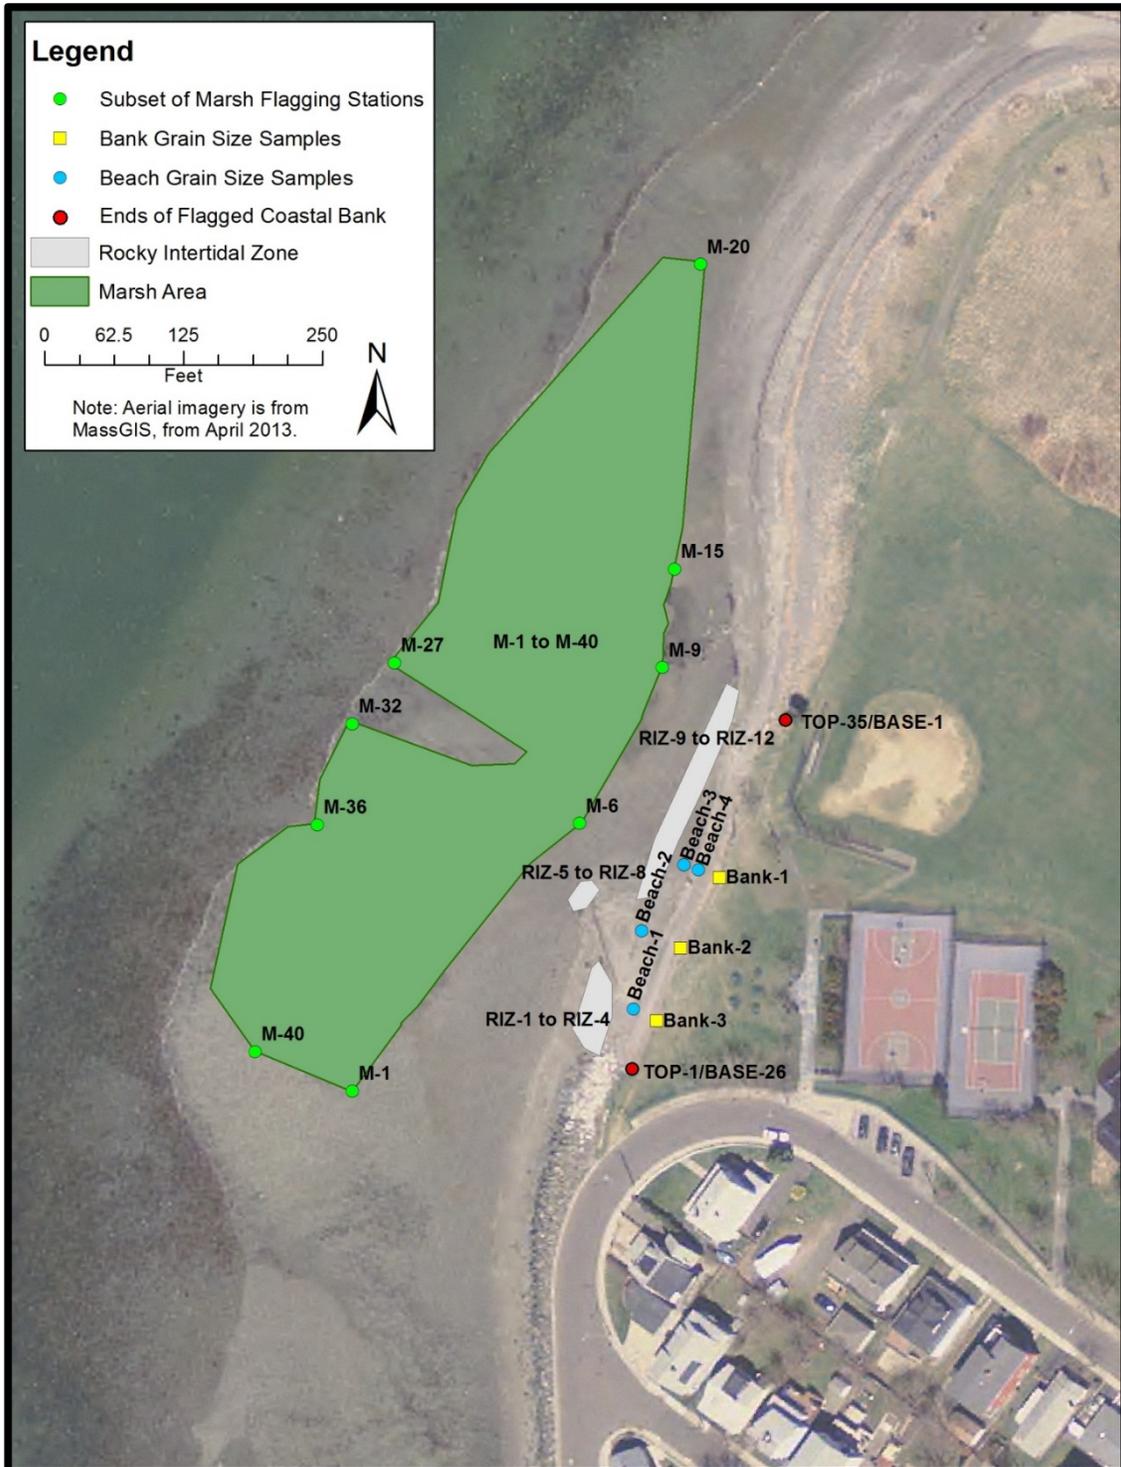
The Salt Marsh delineation was performed pursuant to 310 CMR 10.32 (2), to include all plants adapted to saline conditions. The dominant plant observed at the time of the delineation was salt marsh cord grass (*Spartina alterniflora*). Because it is so early in the season, the *S. alterniflora* was just beginning to sprout again for this growing season. However, the extent of the salt marsh could be discerned from the partially remaining *S. alterniflora* stems from last year. Flagging stations were marked as M-1 to M-40 (Figure 2).

Figure 2. Estimated locations of mapped wetland resources at Coughlin Park.

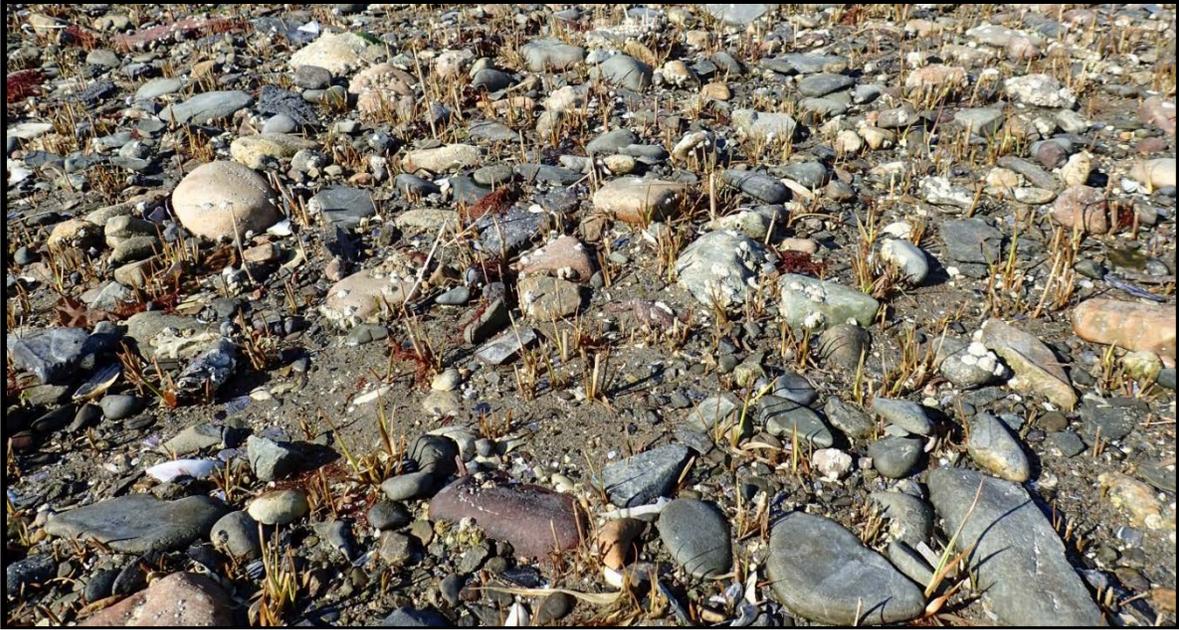
The plant density throughout the salt marsh area was variable. At the far southern end (M-1 to M-6 and M-36 to M-40; Figure 2), the *S. alterniflora* stems are sparse, and were growing in a mix of sand and cobble (Figure 3). This sparse area was separated from a denser section of *S. alterniflora* that was growing in peat by a section of cobble devoid of salt marsh (Figure 4). This bare section is located in the drainage path of the large outfall pipe extending from the end of the stone revetment. This area is captured by wetland flags M-27 to M-32 (Figure 2). The denser, more robust area of *S. alterniflora* north of this drainage area also impounds a tidal pool area between the salt marsh and coastal beach (M-9 to M-15; Figure 2); the *S. alterniflora* grass in

Figure 3. Sparse *S. alterniflora* growing at the southern end of the salt marsh.

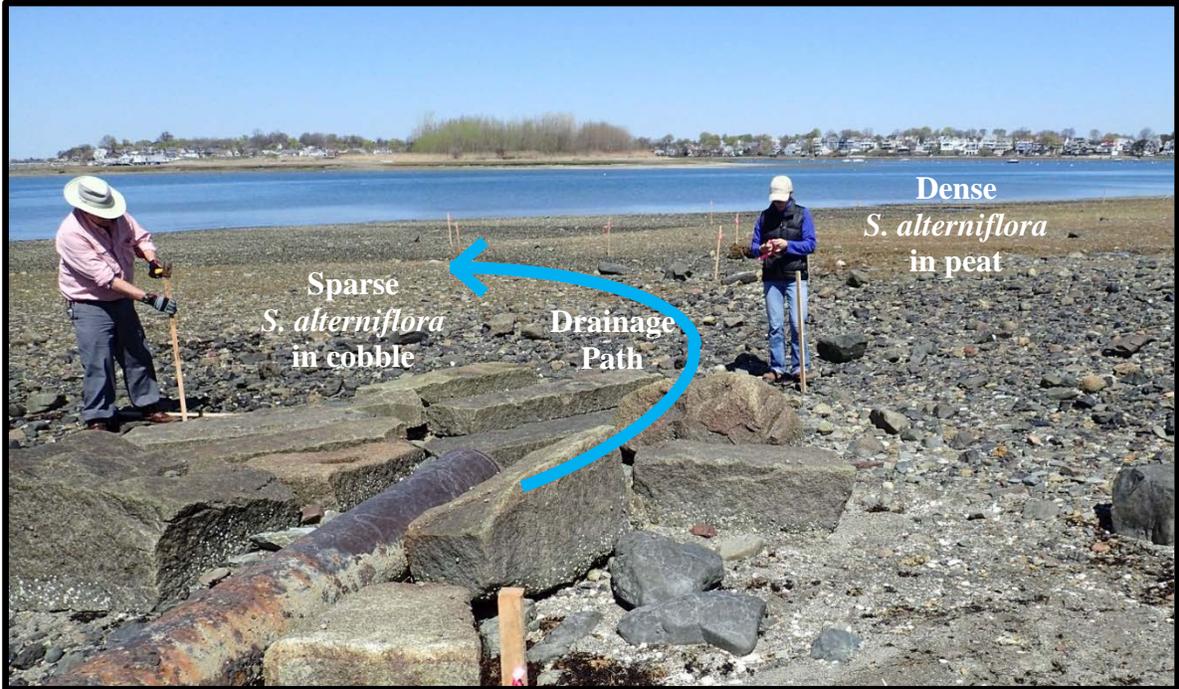
Figure 4. Sparse and dense areas of *S. alterniflora* separated by drainage from outfall pipe.

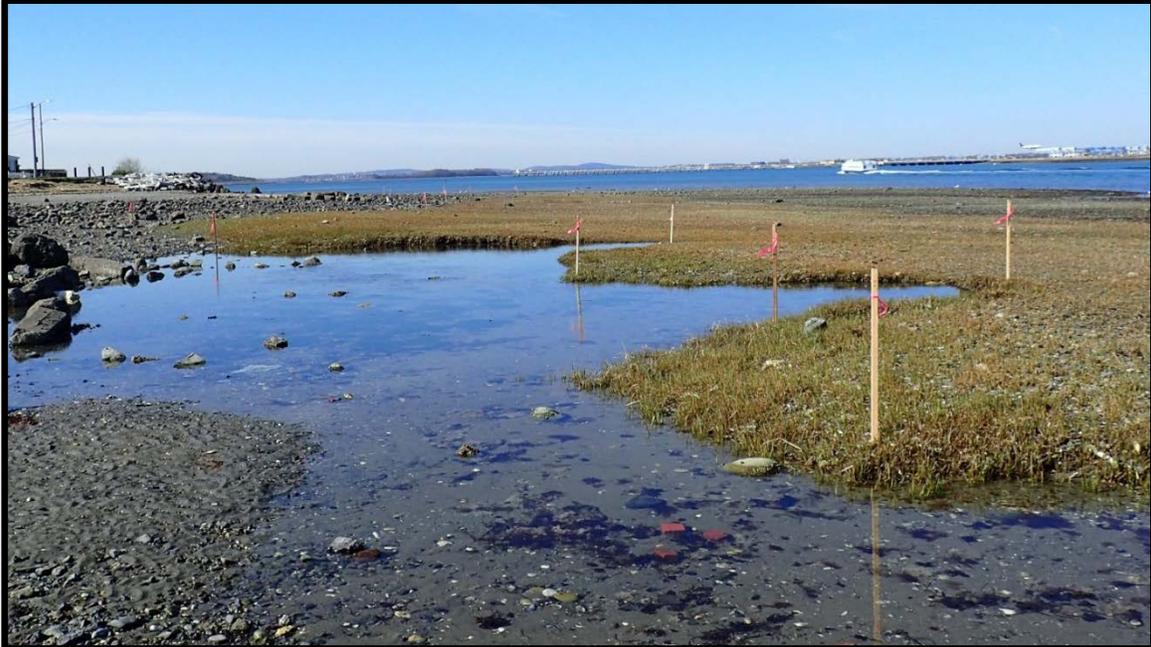
this area had more new shoot growth than in the sparse, more cobble dominated areas (Figure 5). The tidal pool contained a variety of snails, crabs, and macroalgae, as well as schools of small fish.

Figure 5. Dense section of *S. alterniflora* with new shoots in the salt marsh fronting an impounded tide pool.

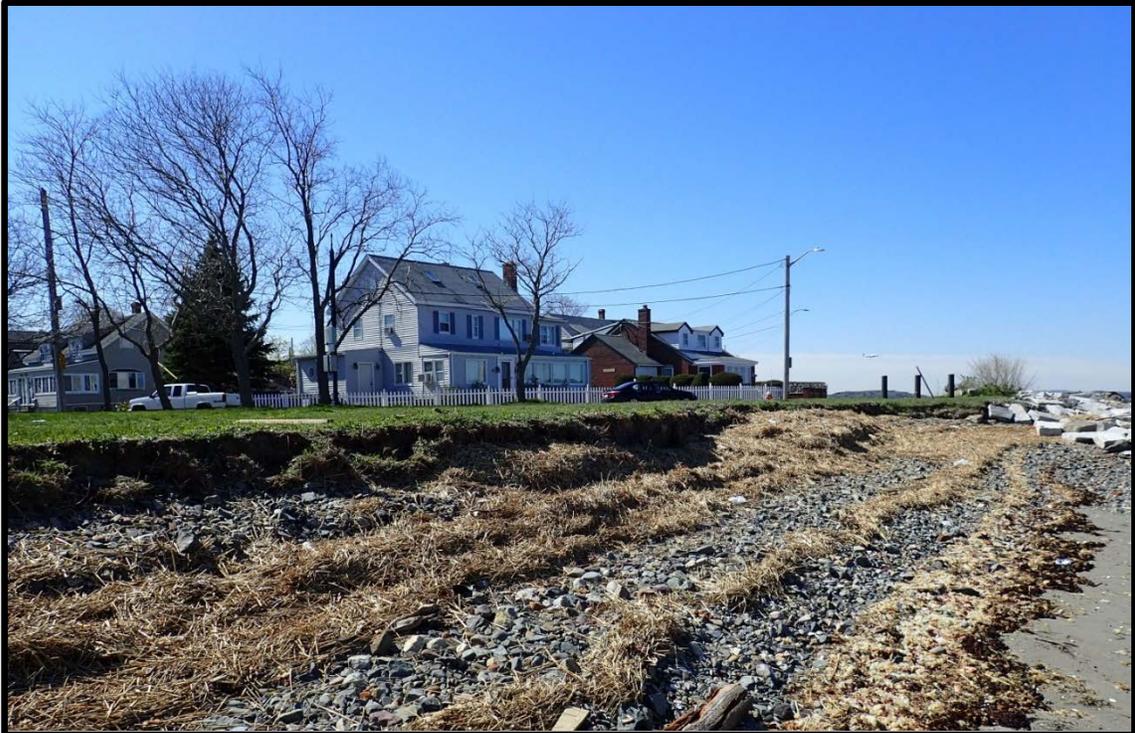
The Coastal Bank delineation was performed pursuant to 310 CMR 10.30 (2). The top of bank was marked with flagging stations labeled TOP-1 to TOP-35, in a south to north direction, while the toe of bank was marked with flagging stations labeled BASE-1 to BASE-26 in a north to south direction (Figure 2). TOP-1 and BASE-26 are located adjacent to the end of the large stone revetment along Grand View Avenue. Most of the top of the Coastal Bank is lawn, and is severely undercut and eroding (Figure 6). Much of this area is fronted by deteriorating hay bales that were placed for runoff control during the construction of the updated recreation facilities at the park last year. The ongoing erosion has exposed sidewalk framing material, filter fabric, and roots, among other objects, as the bank continues to recede. The exception to this, however, is the northern end of the Coastal Bank that was mapped (TOP-33 to TOP-35) less scarped and is an area of transition with a mix of grass and cobble berm (Figure 7).

Figure 6. Eroding coastal bank along southwestern edge of Coughlin Park.

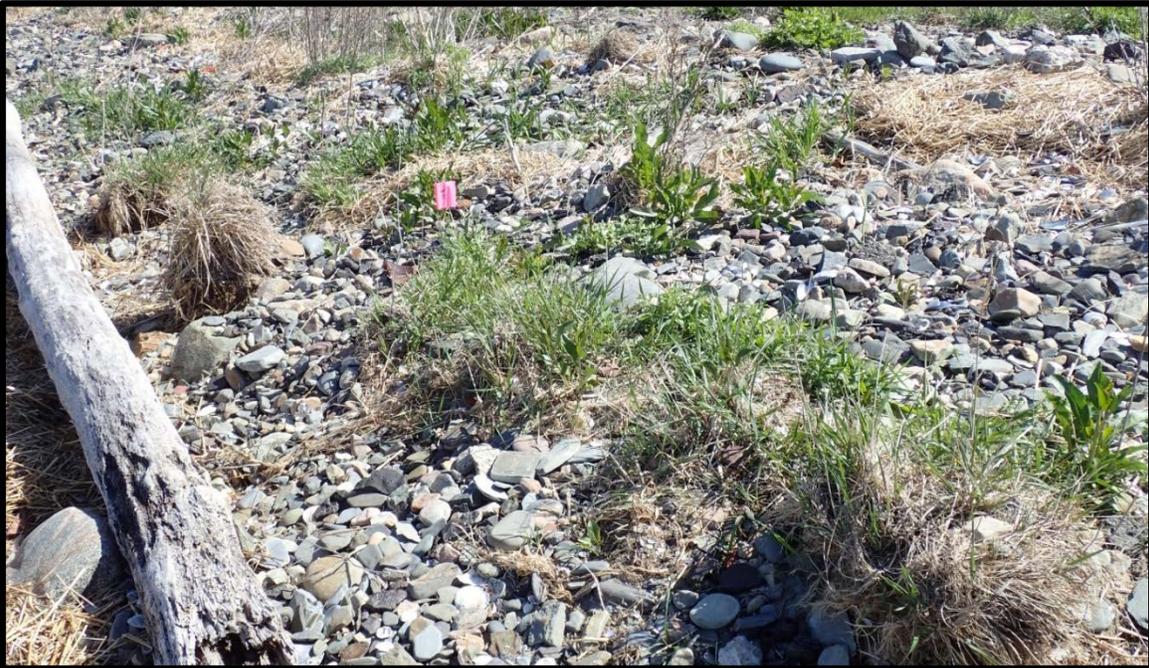
Figure 7. Northern end of Coastal Bank (TOP-35) where it transitions to a cobble berm.

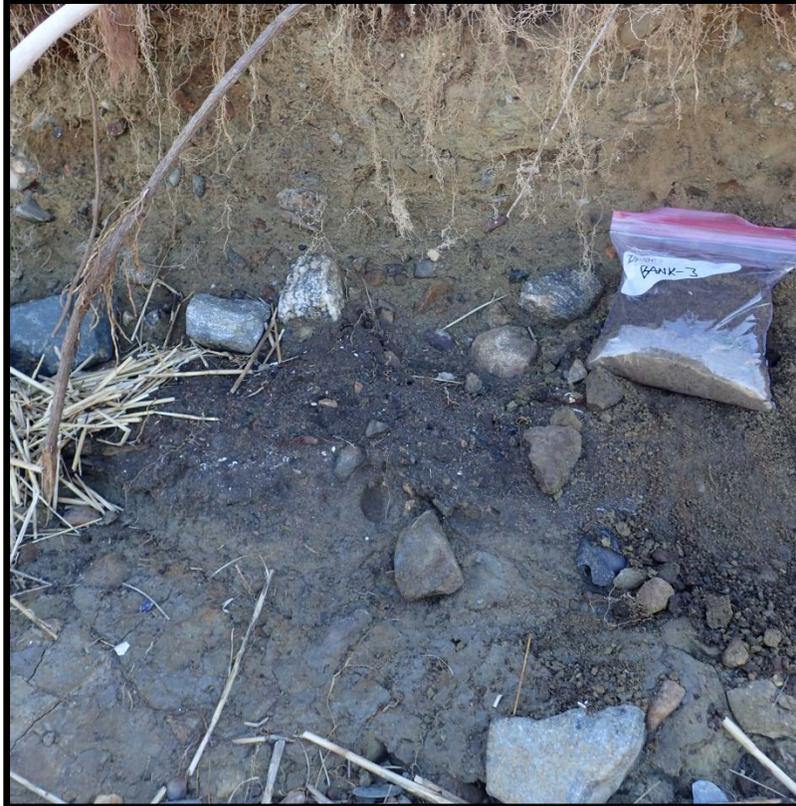
Three samples were collected from the coastal bank to be analyzed for grain size; these were labeled BANK-1, BANK-2, and BANK-3. BANK-1 was collected from the southern end of the Coastal Bank, BANK-2 was collected from approximately the middle portion of the Coastal Bank, and BANK-3 was collected from the northern end of the Coastal Bank (Figure 2). Figure 8 shows an example of the different soil layers observed in the exposed face of the Coastal Bank.

Figure 8. Grain size sample collected from BANK-3. Note the different soil layers, including a significant clay layer at the bottom.

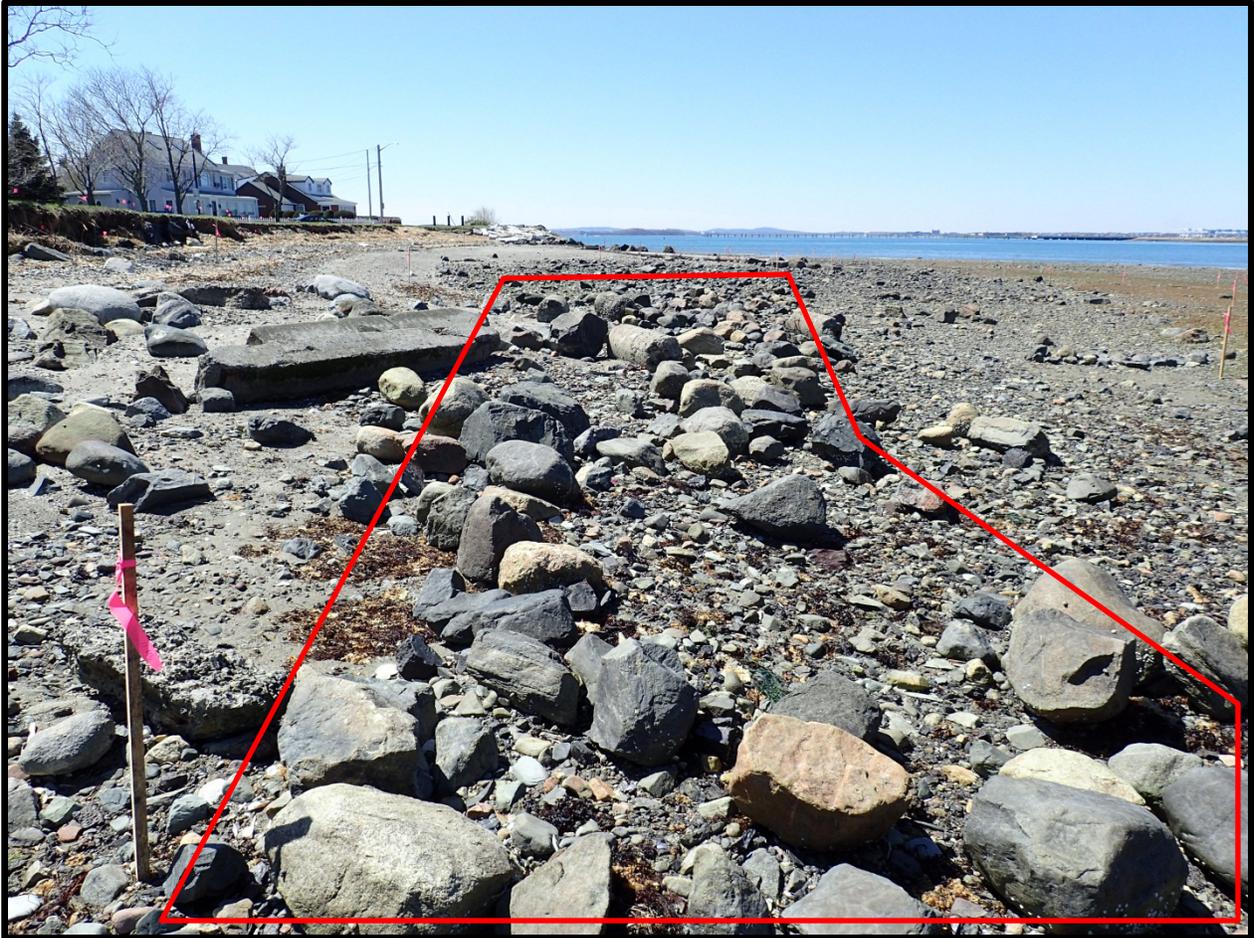
The Rocky Intertidal Shore delineation was performed pursuant to 310 CMR 10.31 (2), to include all boulder strewn areas between the mean high water line and the mean low water line. Three Rocky Intertidal Shore areas were marked with flagging stations labeled RIZ-1 to RIZ-4, RIZ-5 to RIZ-8, and RIZ-9 to RIZ-12 (Figure 2). The most southern Rocky Intertidal Shore area (RIZ-1 to RIZ-4) was a cluster of large boulders located between the revetment and the outfall pipe. The next Rocky Intertidal Shore area (RIZ-5 to RIZ-8) was a cluster of large boulders around the end of the outfall pipe. The third, and largest of the Rocky Intertidal Shore areas, was comprised of small boulders (10 to 24 inches) located in a 15- to 20-foot wide band landward of the salt marsh (Figure 9).

Figure 9. Larger area of Rocky Intertidal Shore (RIZ-9 to RIZ-12) landward of the salt marsh.

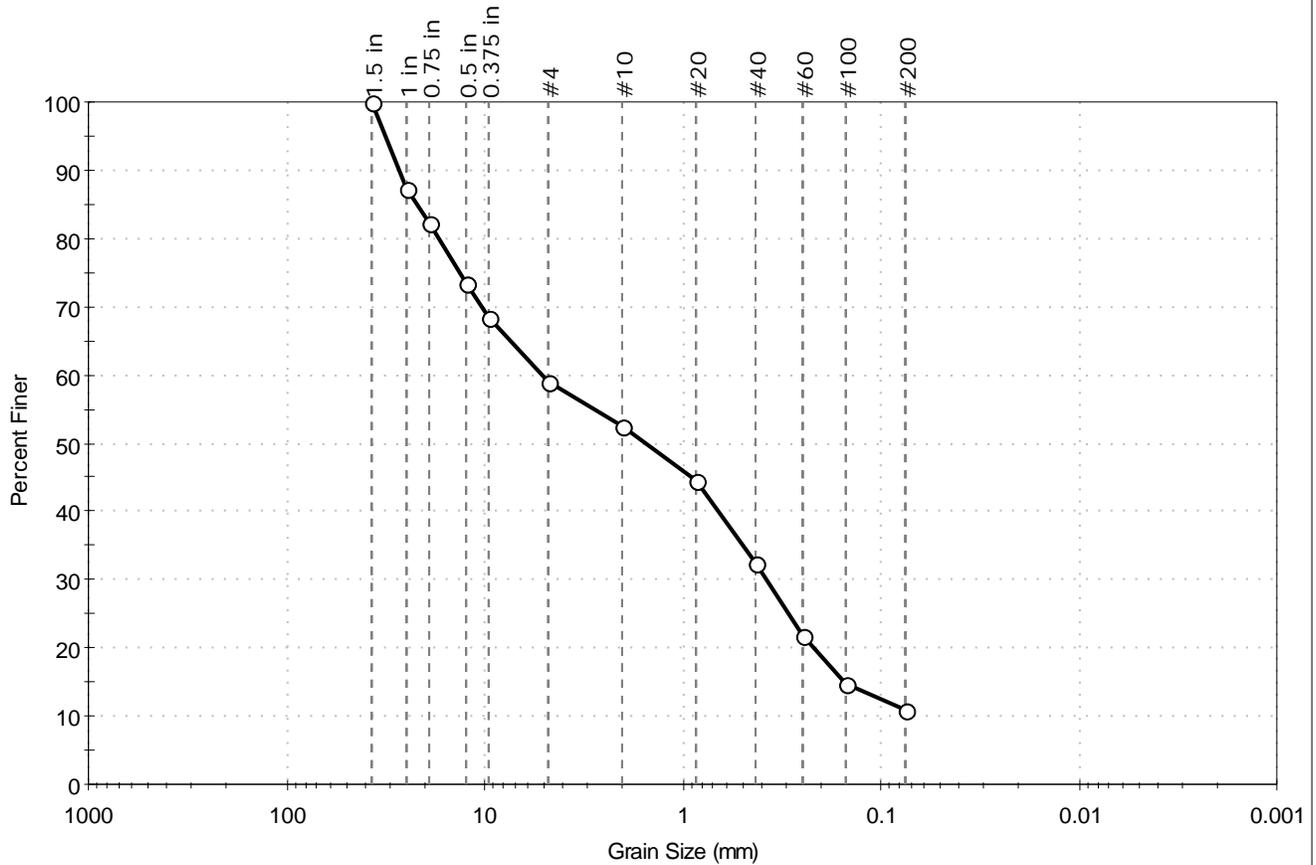
Particle Size Analysis - ASTM D422

Client: Woods Hole Group	Project No: GTX-304691
Project: Sand Samples	
Location: ---	
Boring ID: ---	Sample Type: bag
Sample ID: Bank #1	Test Date: 05/10/16
Depth: ---	Test Id: 376419
Test Comment: ---	Tested By: jbr
Visual Description: Moist, brown sand with silt and gravel	Checked By: emm
Sample Comment: ----

% Cobble	% Gravel	% Sand	% Silt & Clay Size
--	40.9	48.3	10.8

Sieve Name	Sieve Size, mm	Percent Finer	Spec. Percent	Complies
1.5 in	37.50	100		
1 in	25.00	87		
0.75 in	19.00	82		
0.5 in	12.50	74		
0.375 in	9.50	69		
#4	4.75	59		
#10	2.00	52		
#20	0.85	44		
#40	0.42	33		
#60	0.25	22		
#100	0.15	15		
#200	0.075	11

<u>Coefficients</u>	
D ₈₅ = 22.0655 mm	D ₃₀ = 0.3755 mm
D ₆₀ = 5.0846 mm	D ₁₅ = 0.1542 mm
D ₅₀ = 1.5348 mm	D ₁₀ = N/A
C _u = N/A	C _c = N/A

<u>Classification</u>	
ASTM	N/A
AASHTO	Stone Fragments, Gravel and Sand (A-1-b (0))

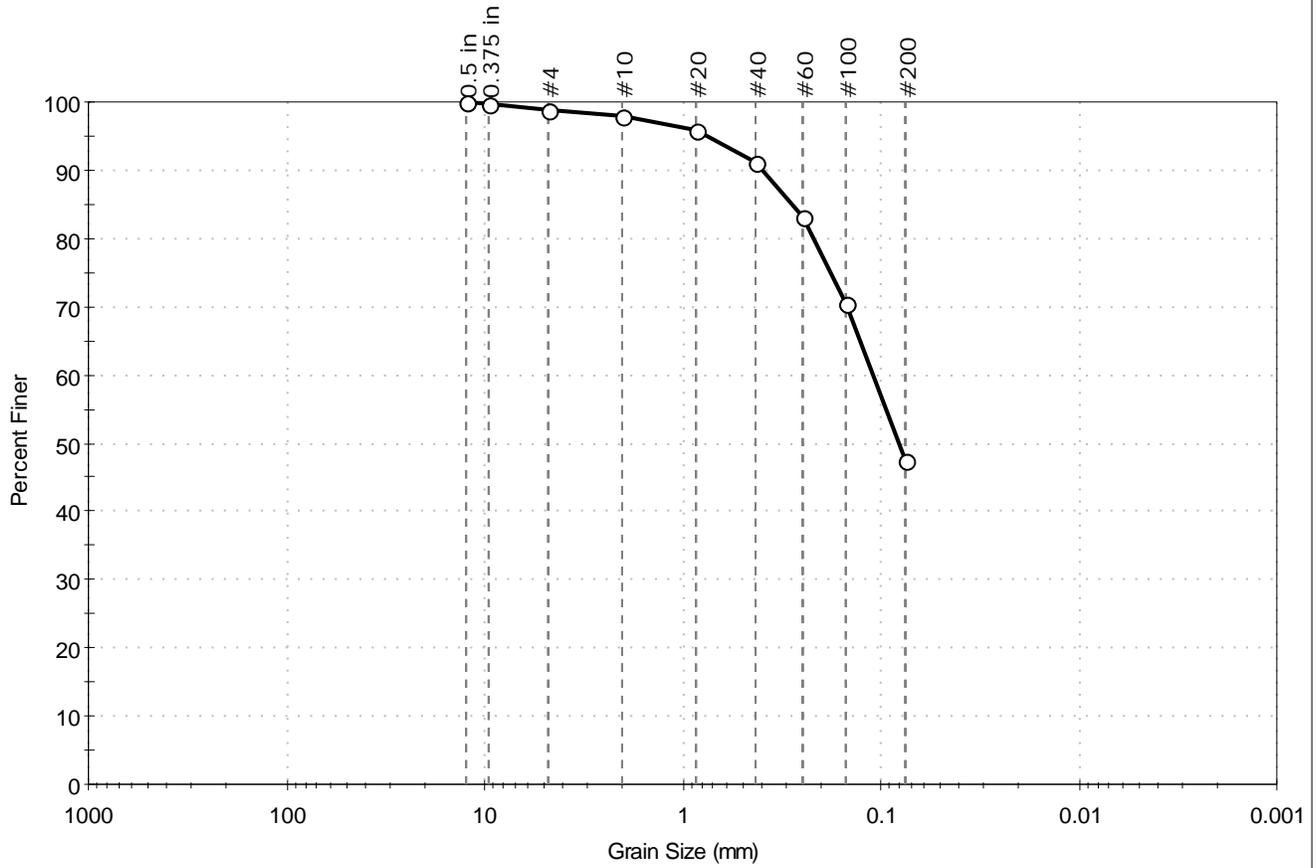
Particle Size Analysis - ASTM D422

Client: Woods Hole Group	Project No: GTX-304691
Project: Sand Samples	
Location: ---	
Boring ID: ---	Sample Type: bag
Sample ID: Bank #2	Tested By: jbr
Depth: ---	Test Date: 05/10/16
Test Comment: ---	Checked By: emm
Visual Description: Moist, very dark brown silty sand	Test Id: 376420
Sample Comment: ---

% Cobble	% Gravel	% Sand	% Silt & Clay Size
---	1.1	51.4	47.5

Sieve Name	Sieve Size, mm	Percent Finer	Spec. Percent	Complies
0.5 in	12.50	100		
0.375 in	9.50	100		
#4	4.75	99		
#10	2.00	98		
#20	0.85	96		
#40	0.42	91		
#60	0.25	83		
#100	0.15	71		
#200	0.075	47

<u>Coefficients</u>	
D ₈₅ = 0.2826 mm	D ₃₀ = N/A
D ₆₀ = 0.1092 mm	D ₁₅ = N/A
D ₅₀ = 0.0809 mm	D ₁₀ = N/A
C _u = N/A	C _c = N/A

<u>Classification</u>	
ASTM	N/A
AASHTO	Silty Soils (A-4 (0))

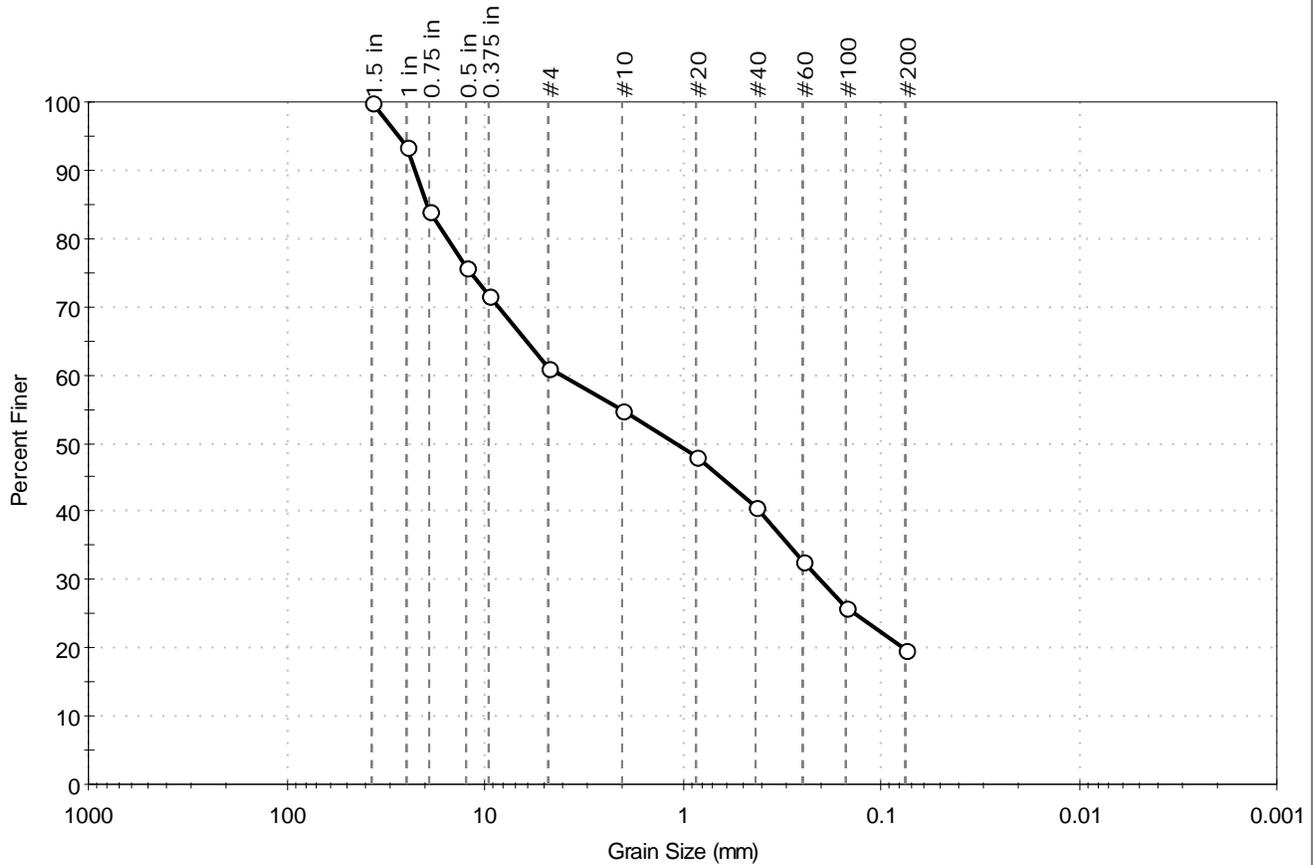
Particle Size Analysis - ASTM D422

Client: Woods Hole Group	Project No: GTX-304691
Project: Sand Samples	
Location: ---	
Boring ID: ---	Sample Type: bag
Sample ID: Bank #3	Tested By: jbr
Depth: ---	Test Date: 05/10/16
Test Comment: ---	Checked By: emm
Visual Description: Moist, dark brown silty sand with gravel	Test Id: 376421
Sample Comment: ---

% Cobble	% Gravel	% Sand	% Silt & Clay Size
---	38.9	41.4	19.7

Sieve Name	Sieve Size, mm	Percent Finer	Spec. Percent	Complies
1.5 in	37.50	100		
1 in	25.00	94		
0.75 in	19.00	84		
0.5 in	12.50	76		
0.375 in	9.50	72		
#4	4.75	61		
#10	2.00	55		
#20	0.85	48		
#40	0.42	41		
#60	0.25	33		
#100	0.15	26		
#200	0.075	20

<u>Coefficients</u>	
D ₈₅ = 19.4975 mm	D ₃₀ = 0.2021 mm
D ₆₀ = 4.1026 mm	D ₁₅ = N/A
D ₅₀ = 1.0893 mm	D ₁₀ = N/A
C _u = N/A	C _c = N/A

<u>Classification</u>	
ASTM	N/A
AASHTO	Stone Fragments, Gravel and Sand (A-1-b (0))

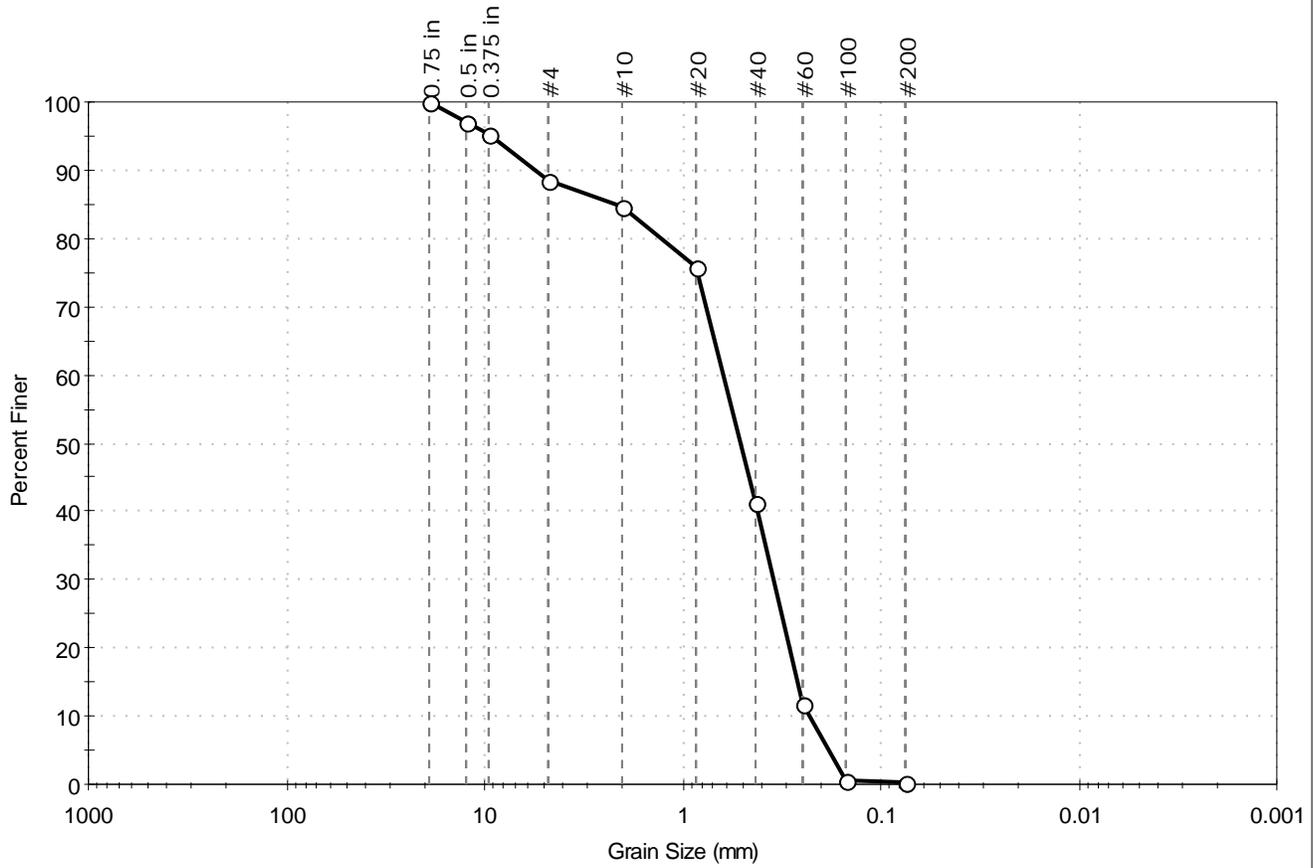
Particle Size Analysis - ASTM D422

Client: Woods Hole Group	Project No: GTX-304691
Project: Sand Samples	
Location: ---	
Boring ID: ---	Sample Type: bag
Sample ID: Beach #1	Tested By: jbr
Depth: ---	Test Date: 05/10/16
Test Comment: ---	Checked By: emm
Visual Description: Moist, olive sand	Test Id: 376415
Sample Comment: ---

% Cobble	% Gravel	% Sand	% Silt & Clay Size
--	11.6	88.1	0.3

Sieve Name	Sieve Size, mm	Percent Finer	Spec. Percent	Complies
0.75 in	19.00	100		
0.5 in	12.50	97		
0.375 in	9.50	95		
#4	4.75	88		
#10	2.00	85		
#20	0.85	76		
#40	0.42	41		
#60	0.25	12		
#100	0.15	1		
#200	0.075	0.3

<u>Coefficients</u>	
D ₈₅ = 2.2304 mm	D ₃₀ = 0.3471 mm
D ₆₀ = 0.6188 mm	D ₁₅ = 0.2651 mm
D ₅₀ = 0.5063 mm	D ₁₀ = 0.2308 mm
C _u = 2.681	C _c = 0.844

<u>Classification</u>	
<u>ASTM</u>	Poorly graded sand (SP)
<u>AASHTO</u>	Stone Fragments, Gravel and Sand (A-1-b (1))

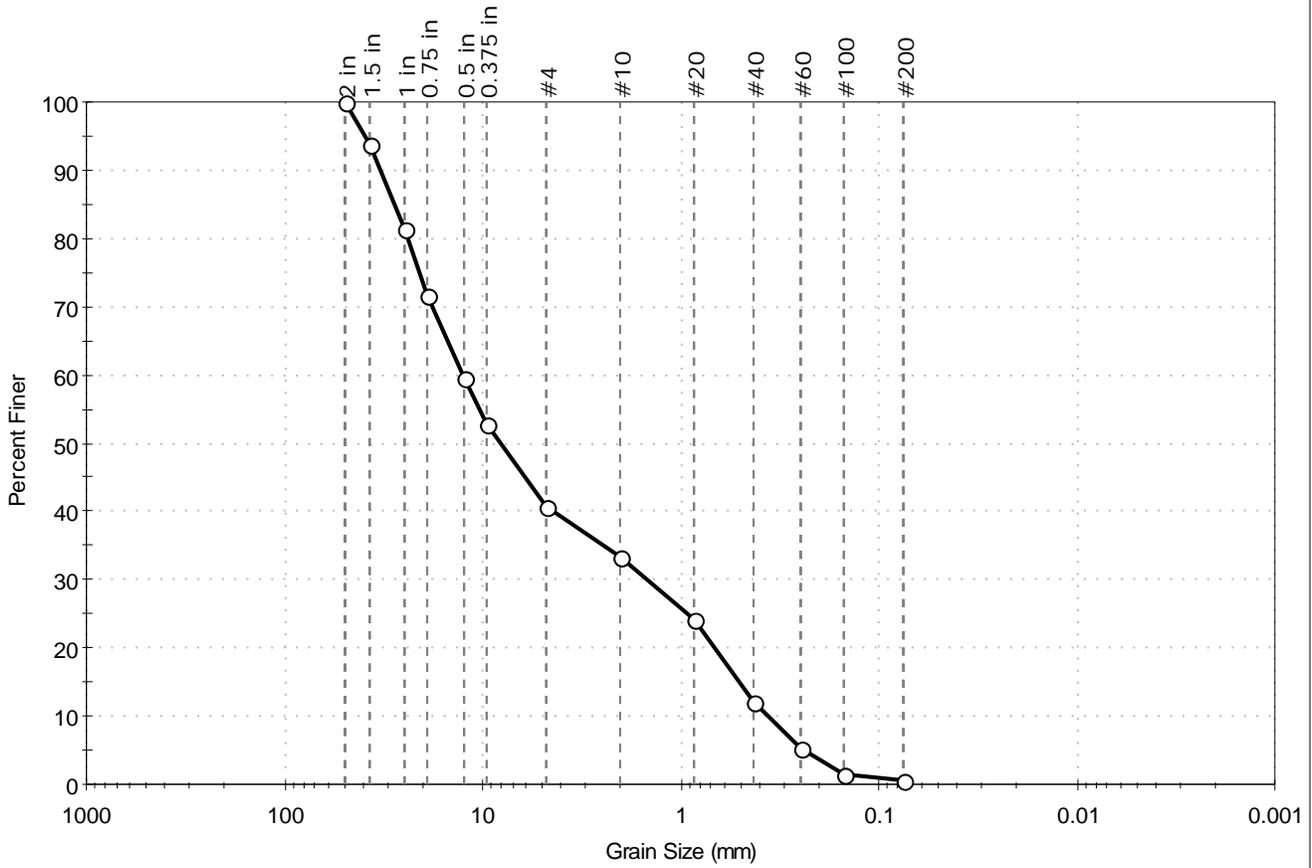
Particle Size Analysis - ASTM D422

Client: Woods Hole Group	Project No: GTX-304691
Project: Sand Samples	
Location: ---	
Boring ID: ---	Sample Type: bag
Sample ID: Beach #2	Test Date: 05/10/16
Depth: ---	Test Id: 376416
Test Comment: ---	Tested By: jbr
Visual Description: Moist, dark brown gravel with sand	Checked By: emm
Sample Comment: ---

% Cobble	% Gravel	% Sand	% Silt & Clay Size
--	59.2	40.3	0.5

Sieve Name	Sieve Size, mm	Percent Finer	Spec. Percent	Complies
2 in	50.00	100		
1.5 in	37.50	94		
1 in	25.00	81		
0.75 in	19.00	72		
0.5 in	12.50	59		
0.375 in	9.50	53		
#4	4.75	41		
#10	2.00	33		
#20	0.85	24		
#40	0.42	12		
#60	0.25	5		
#100	0.15	1		
#200	0.075	0.5

<u>Coefficients</u>	
D ₈₅ = 28.0541 mm	D ₃₀ = 1.4489 mm
D ₆₀ = 12.7171 mm	D ₁₅ = 0.5020 mm
D ₅₀ = 8.1061 mm	D ₁₀ = 0.3618 mm
C _u = 35.150	C _c = 0.456

<u>Classification</u>	
<u>ASTM</u>	Poorly graded gravel with sand (GP)
<u>AASHTO</u>	Stone Fragments, Gravel and Sand (A-1-a (1))

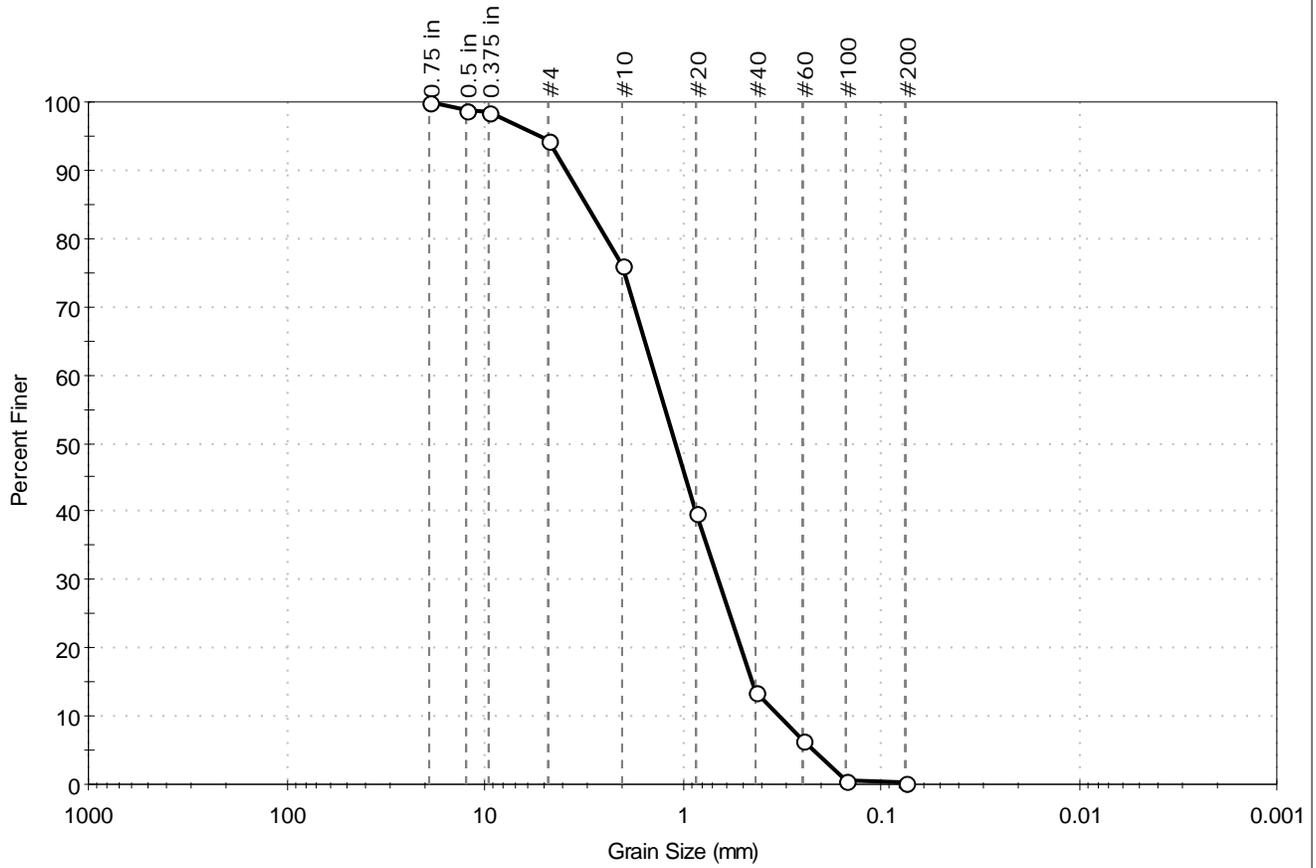
Particle Size Analysis - ASTM D422

Client: Woods Hole Group	Project No: GTX-304691
Project: Sand Samples	
Location: ---	
Boring ID: ---	Sample Type: bag
Sample ID: Beach #3	Tested By: jbr
Depth: ---	Test Date: 05/10/16
Test Comment: ---	Checked By: emm
Visual Description: Moist, very dark olive gray sand	Test Id: 376417
Sample Comment: ---

% Cobble	% Gravel	% Sand	% Silt & Clay Size
---	5.6	94.1	0.3

Sieve Name	Sieve Size, mm	Percent Finer	Spec. Percent	Complies
0.75 in	19.00	100		
0.5 in	12.50	99		
0.375 in	9.50	98		
#4	4.75	94		
#10	2.00	76		
#20	0.85	40		
#40	0.425	13		
#60	0.25	7		
#100	0.15	1		
#200	0.075	0.3

<u>Coefficients</u>	
D ₈₅ = 3.0387 mm	D ₃₀ = 0.6578 mm
D ₆₀ = 1.3694 mm	D ₁₅ = 0.4423 mm
D ₅₀ = 1.0829 mm	D ₁₀ = 0.3245 mm
C _u = 4.220	C _c = 0.974

<u>Classification</u>	
<u>ASTM</u>	Poorly graded sand (SP)
<u>AASHTO</u>	Stone Fragments, Gravel and Sand (A-1-b (1))

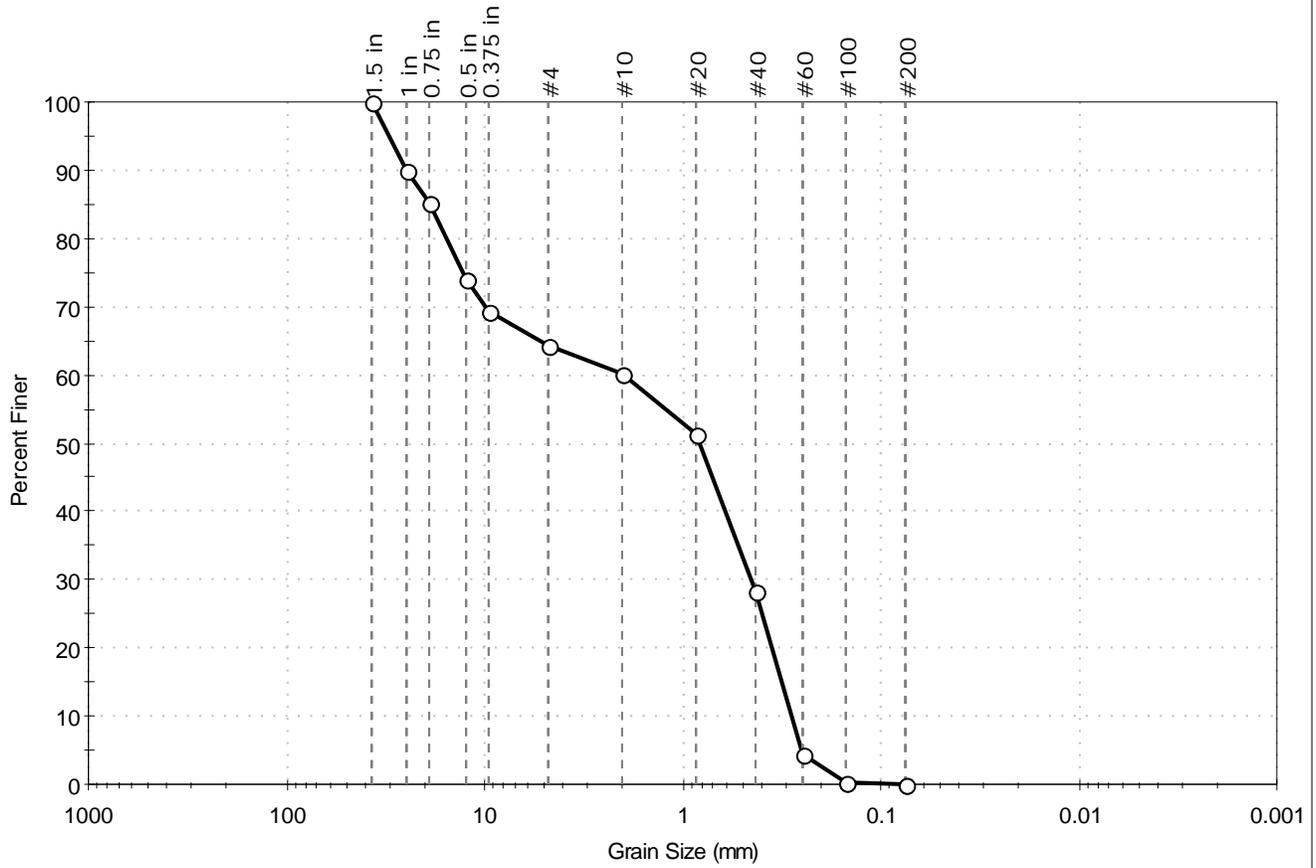
Particle Size Analysis - ASTM D422

Client: Woods Hole Group	Project No: GTX-304691
Project: Sand Samples	
Location: ---	
Boring ID: ---	Sample Type: bag
Sample ID: Beach #4	Tested By: jbr
Depth: ---	Test Date: 05/10/16
Test Comment: ---	Checked By: emm
Visual Description: Moist, gray sand with gravel	Test Id: 376418
Sample Comment: ---

% Cobble	% Gravel	% Sand	% Silt & Clay Size
--	35.8	64.1	0.1

Sieve Name	Sieve Size, mm	Percent Finer	Spec. Percent	Complies
1.5 in	37.50	100		
1 in	25.00	90		
0.75 in	19.00	85		
0.5 in	12.50	74		
0.375 in	9.50	69		
#4	4.75	64		
#10	2.00	60		
#20	0.85	51		
#40	0.42	28		
#60	0.25	5		
#100	0.15	0		
#200	0.075	0.1

<u>Coefficients</u>	
D ₈₅ = 18.8262 mm	D ₃₀ = 0.4476 mm
D ₆₀ = 1.9725 mm	D ₁₅ = 0.3158 mm
D ₅₀ = 0.8147 mm	D ₁₀ = 0.2823 mm
C _u = 6.987	C _c = 0.360

<u>Classification</u>	
<u>ASTM</u>	Poorly graded sand with gravel (SP)
<u>AASHTO</u>	Stone Fragments, Gravel and Sand (A-1-b (1))
