# INCREASING COASTAL RESILIENCY AT COUGHLIN PARK

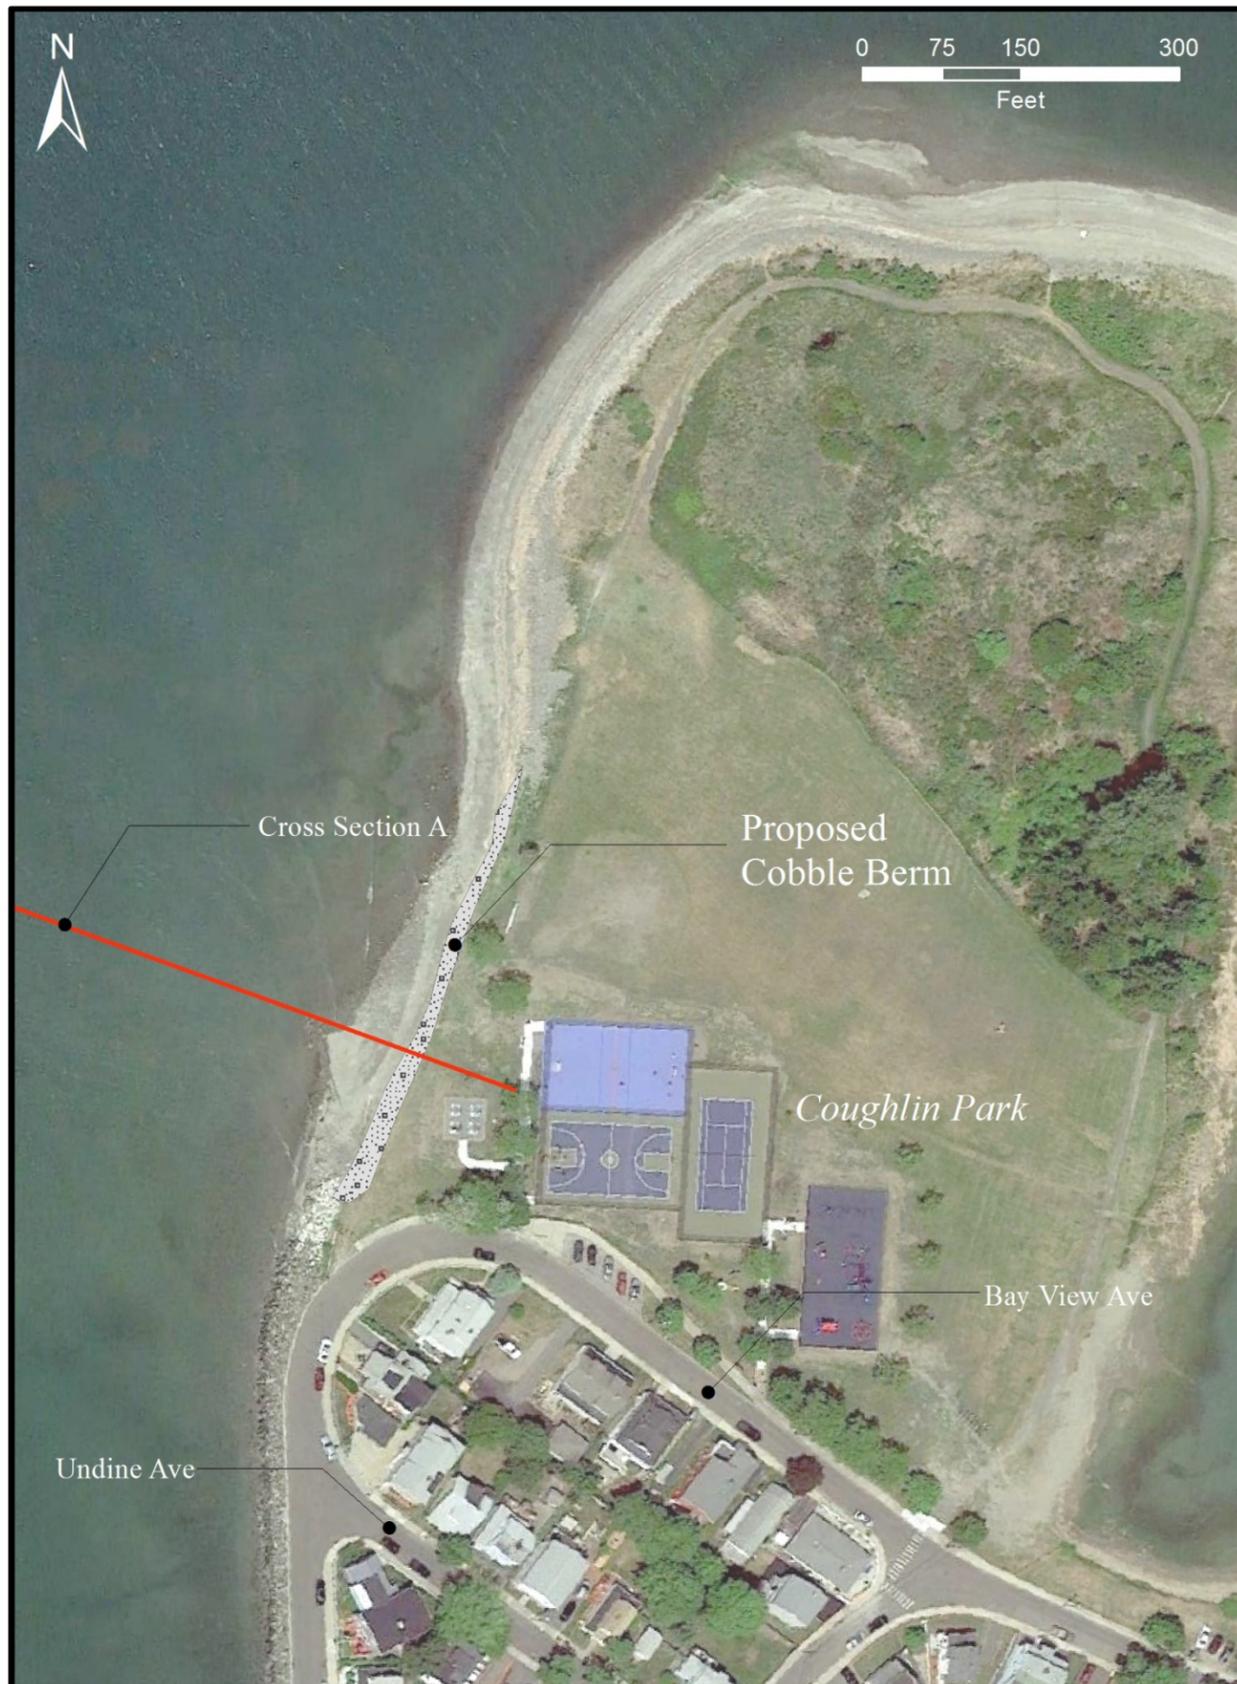
The aerial photograph on the left shows Coughlin Park, which is located on the western shores of Winthrop, MA. The shoreline and bank immediately north of the existing sea wall have been eroding at ~1.5 feet/year. The project goal was to increase coastal resiliency and mitigate shoreline erosion at this location. The chosen alternative consists of fiber rolls and regrading to stabilize the bank, as well as cobble bank nourishment. The illustration below shows the cobble bank nourishment, fiber rolls, and bank regrading proposed at the site.

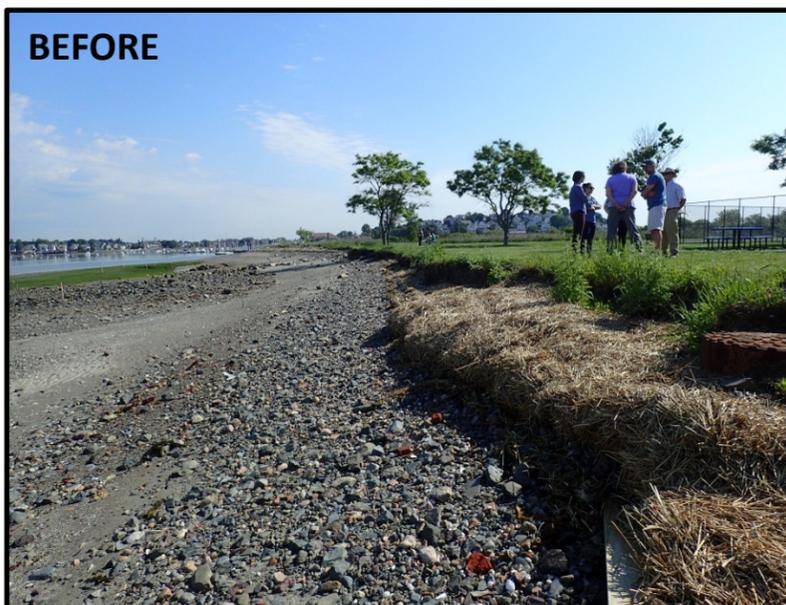
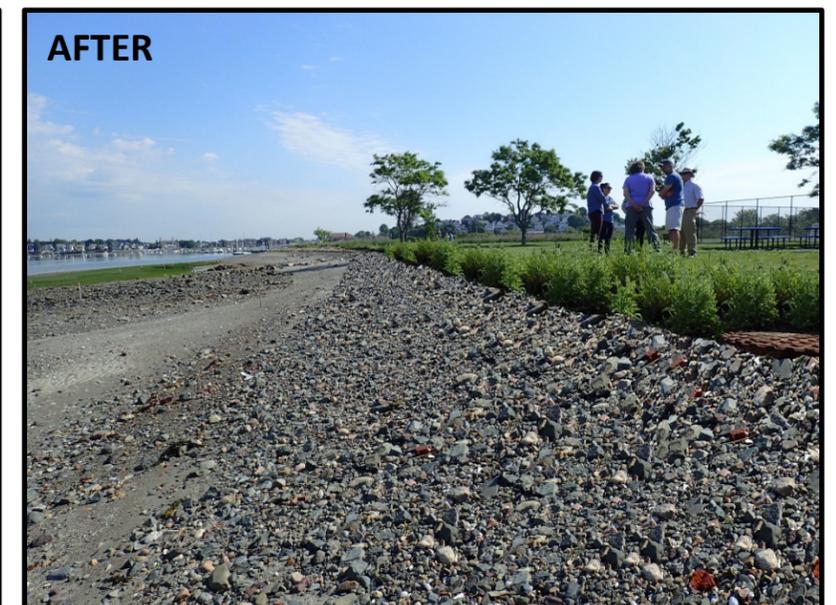
The fiber rolls and cobble bank nourishment will protect the bank and increase coastal resiliency at Coughlin Park. Below is a photo of the existing conditions (Before), as well as an artist's rendition of the finalized project (After). The before photograph shows the undercut and eroding coastal bank, as well as the existing cobble beach. The after photograph shows the completed cobble bank and berm, which will dissipate wave energy and mitigate shoreline erosion, while also providing protection to the installed fiber rolls.
